Water Main Break Rates In the USA and Canada: A Comprehensive Study

Steven Folkman
Utah State University

March 2018

An Asset Management Planning Tool for Water Utilities

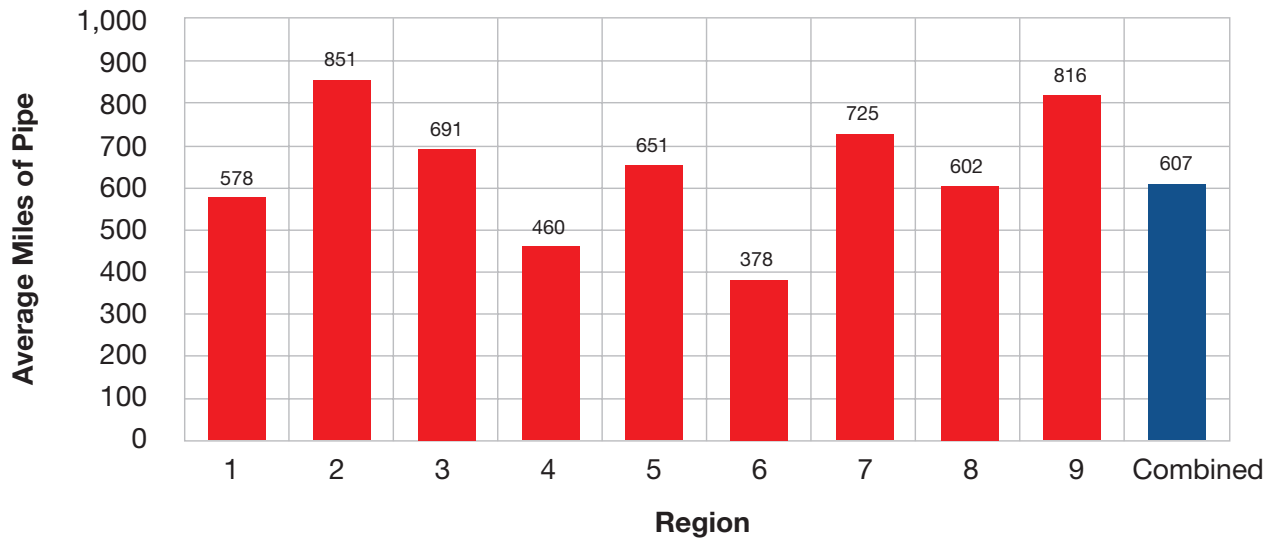
Figure 4 shows the average miles of pipe per utility for the basic survey by region. Region 2 had the highest average pipe length of 851 miles and Region 6 had the smallest with 378 miles. Overall, based on the basic survey, an average utility participant had 607 miles of pipe and served 186,752 people. For comparison, the 2012 survey results reported an average utility had 626 miles of pipe and served 164,325 people, which are similar results. The 2012 survey had 188 respondents covering 117,603 miles of pipe with failure data and thus the 2018 basic survey had a 49% increase in respondents and 45% more miles of pipe. This increase in survey coverage increases the statistical validity of this study.

FIGURE 4: AVERAGE MILES OF PIPE FROM EACH REGION RESPONDING TO THE BASIC SURVEY

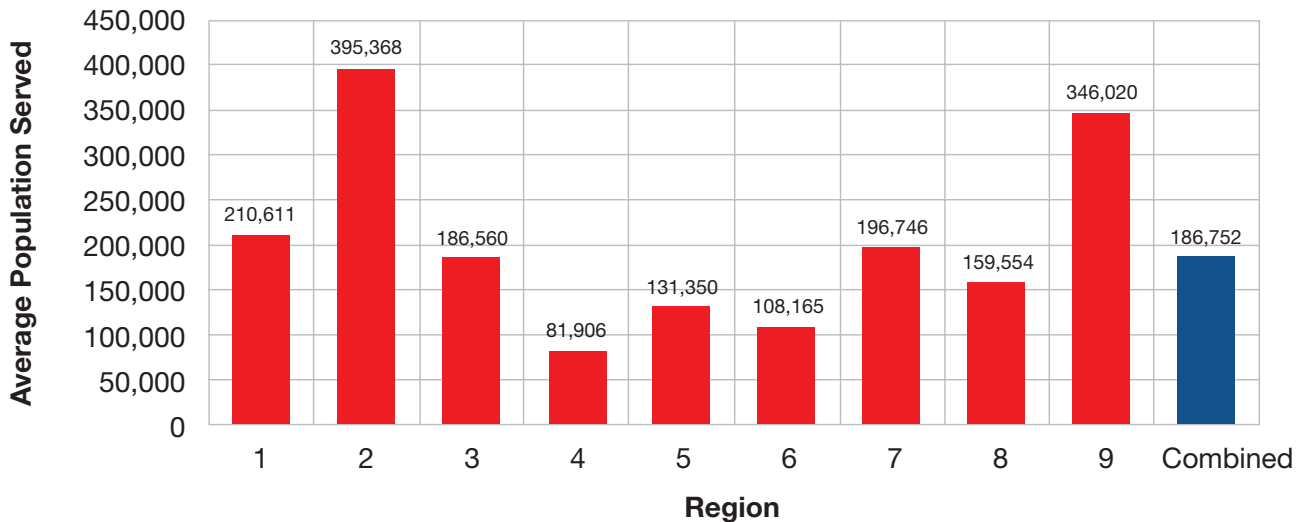
Figure 5 shows the average population served per utility for each region in Figure 1. The average population served per utility for the entire basic survey was 186,752.

FIGURE 5: AVERAGE POPULATION SERVED FROM EACH REGION RESPONDING TO THE BASIC SURVEY

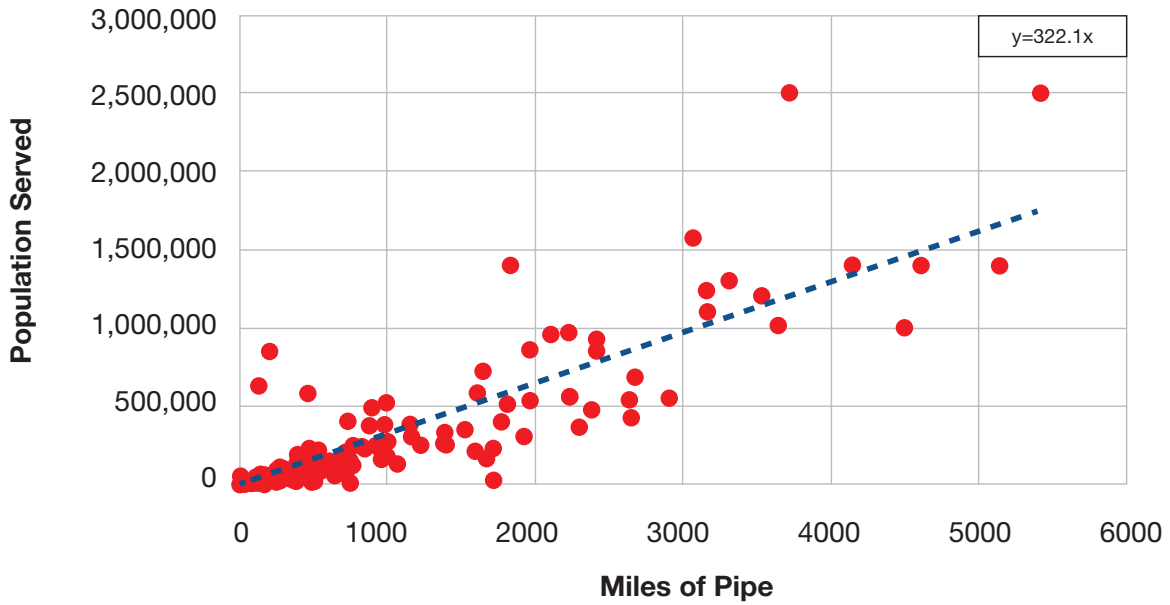
Figure 7 illustrates the relationship between the population served by the utilities participating in the basic survey and the number of miles of water main pipe. The trend line and equation are a best fit to the data. The slope of this line indicates that there are on average 322 people served for each mile of water main installed. Figure 7 tends to be biased by the points most distant from the origin. Figure 8 utilizes the data in Table 1 to compute average population served per mile of pipe for each region. We see that this produces an overall average of 308 people served per mile. More rural areas such as Regions 3, 4, and 5 have lower population to miles of pipe ratios as expected. Utilities that were exclusively transmission systems were excluded. This compares with a commonly used estimate of 325 people per mile (Eidinger, 2001). The 2012 survey reported this value as 264 people served per mile. Pipe breaks in utilities with a higher count of people per mile would have a greater impact on the community.

FIGURE 7: POPULATION SERVED RELATIVE TO TOTAL MILES OF PIPE FROM THE BASIC SURVEY

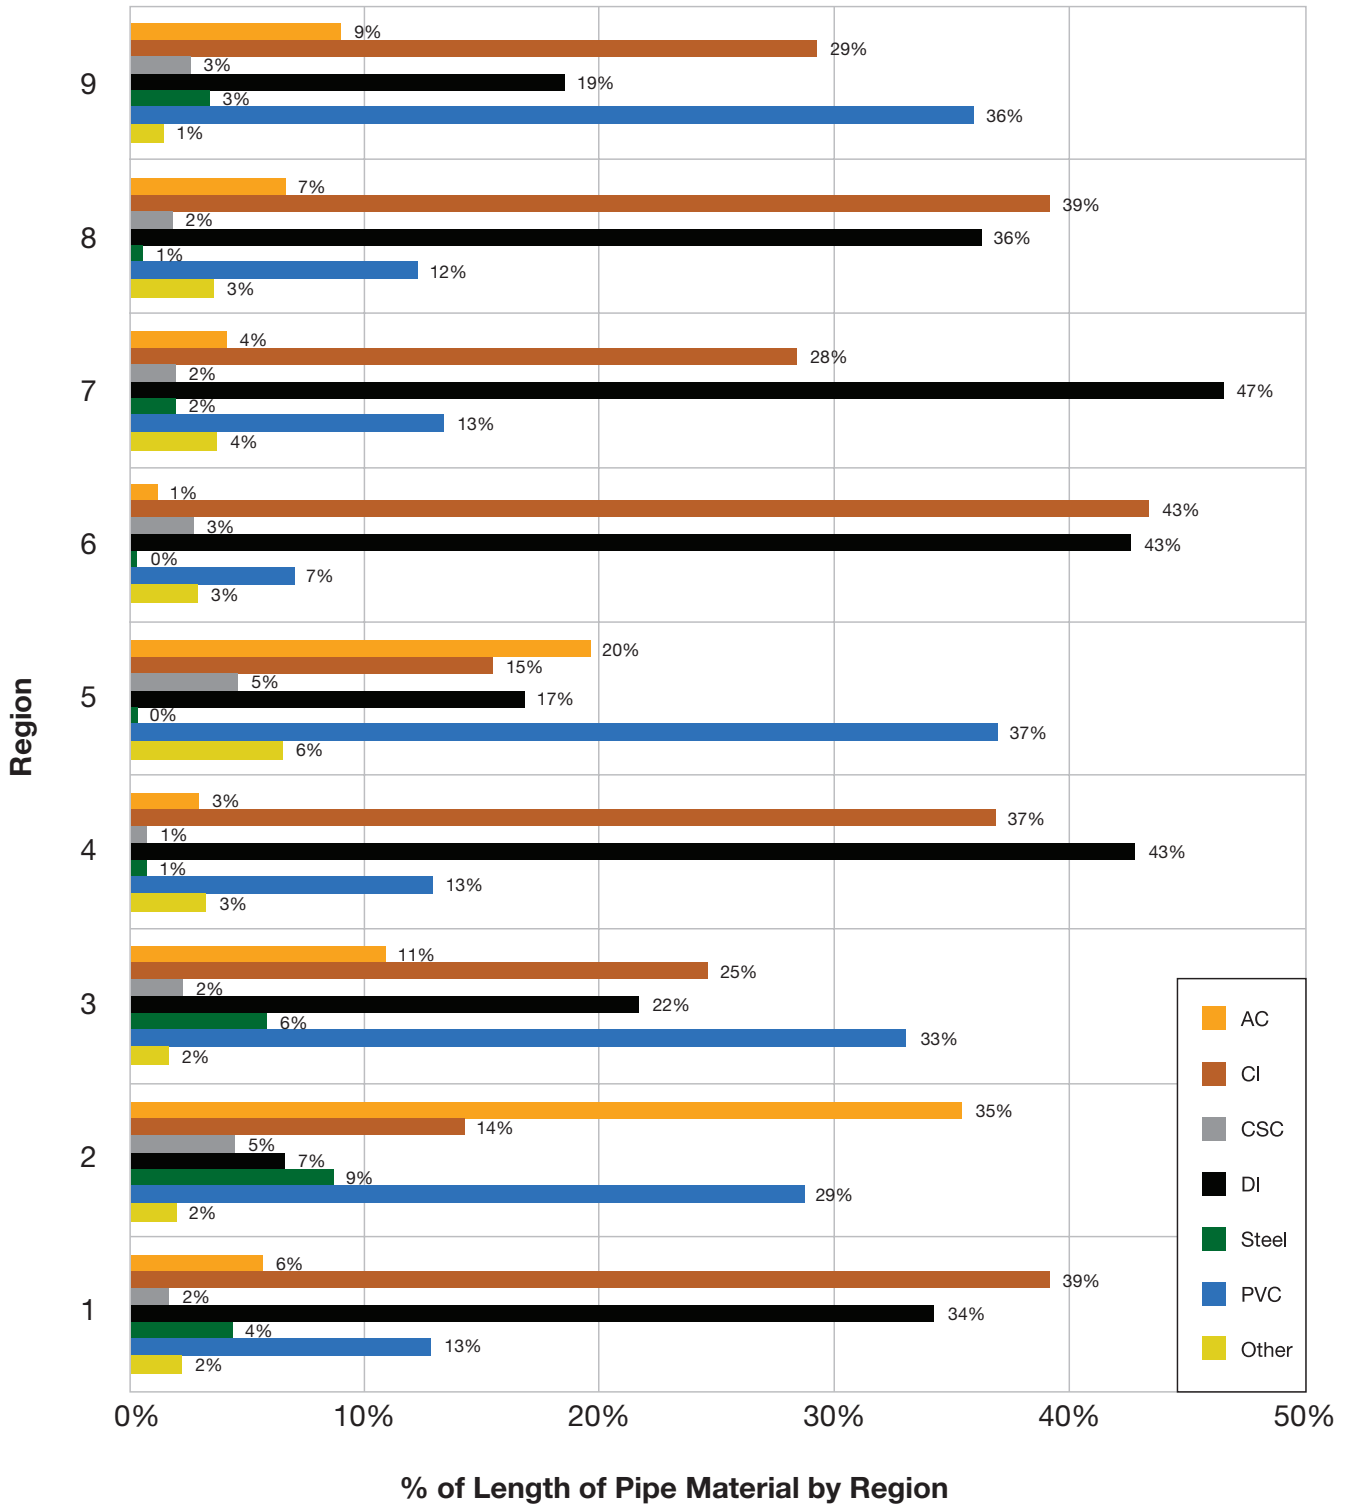
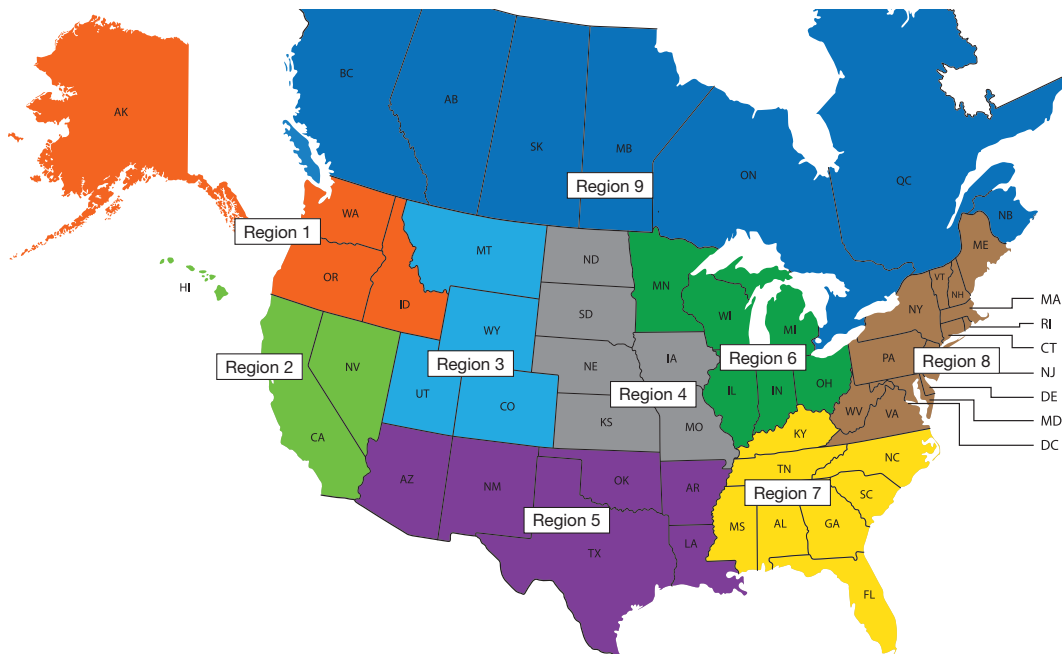
Figure 11 illustrates the regional distribution of pipe material usage as a percentage of the total length in that region. It is interesting to note the significant differences in regional pipe material utilization. Cast iron (CI) and ductile iron (DI) pipe represent approximately 86% of the water mains in Region 6 and over 75% in Regions 4, 7, and 8. PVC has a leading role in Regions 3, 5 and 9 and is slightly behind asbestos cement (AC) pipe in Region 2. AC pipe has a significant presence in Regions 2 and 5. Region 2 is unique in that it is the only region where AC pipe is the most common material. This suggests that the selection and use of pipe materials are based on historical preference versus comparative cost analysis or environmental conditions. Since CI and AC pipes are no longer manufactured in the US and Canada, the use of these materials in water systems should be decreasing with time as they are replaced. By applying asset management best practices, life cycle cost analysis should be used to do a comparative total cost of ownership evaluation of what pipe material should replace the CI and AC pipes.

FIGURE 11: REGIONAL PERCENTAGE OF LENGTH OF PIPE BY MATERIAL TYPE (BASIC SURVEY)

Water main pipe material usage varies significantly over geographic regions (see Figure 11). This suggests that the selection and use of pipe materials are based on historical preference versus comparative cost analysis or environmental conditions. The upper northwest and eastern half of the USA (Regions 1, 4, 6, 7, and 8 as illustrated in Figure 1) have either cast iron or ductile iron pipe for much of the installed pipe length. Regions 3, 5, and 9 have more PVC pipe than any other material. The most common pipe material in Region 2 is asbestos cement and it is unique in that respect.

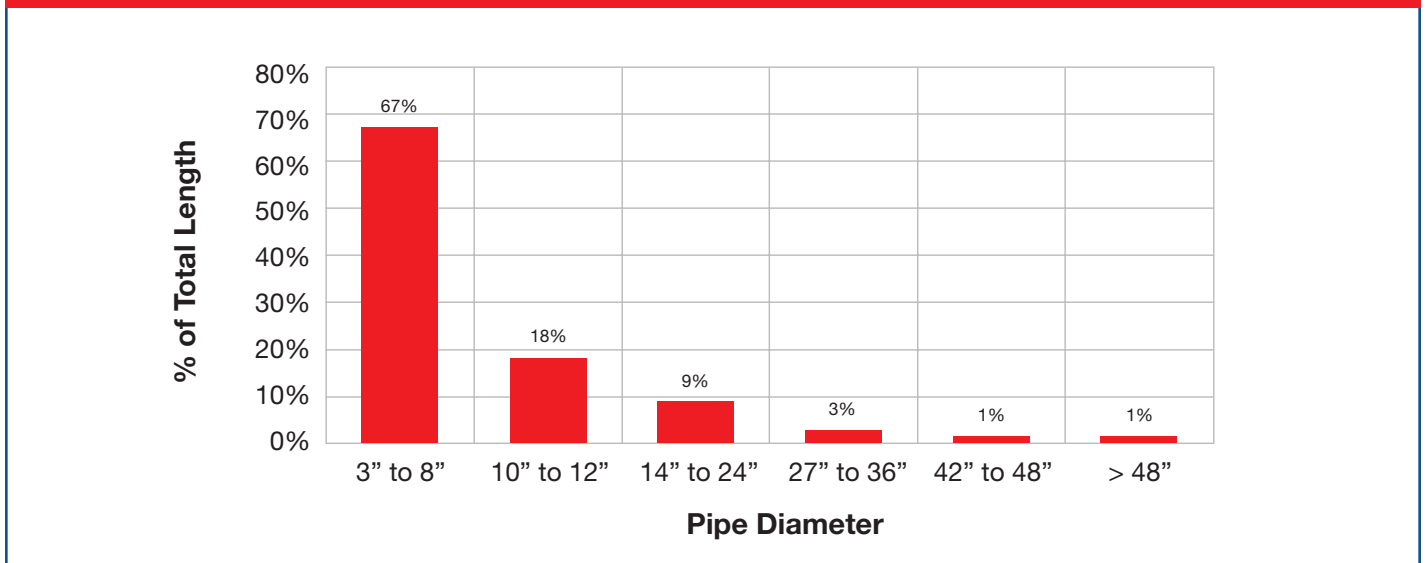
The detailed survey respondents were also asked to break down the fraction of total installed pipe length by six pipe diameter categories. Figure 15 illustrates the percentage of water main that fit into each size range. Figure 15 indicates that approximately 67% of the installed pipe is 8 inches or less in diameter. The 2012 survey found that 66% of the pipe was 8 inches or less in diameter showing good agreement. Earlier studies assumed 73% of water pipes were 10 inches or less in diameter (Stone et al., 2002). Figure 16 illustrates the diameter distribution for each material type. Figure 16 shows that large diameter transmission pipes are dominated by steel and concrete pipe materials with 18% of all concrete pipe and 14% of all steel pipe having a diameter greater than 48-inches. Figure 17 illustrates the percent of total length of all pipe materials broken down by material type and diameter. Figure 17 illustrates that cast iron pipe from 3 to 8 inches in diameter represents over 19% of the installed pipe.

FIGURE 15: PERCENT OF TOTAL LENGTH OF PIPE BY SIZE FROM THE DETAILED SURVEY

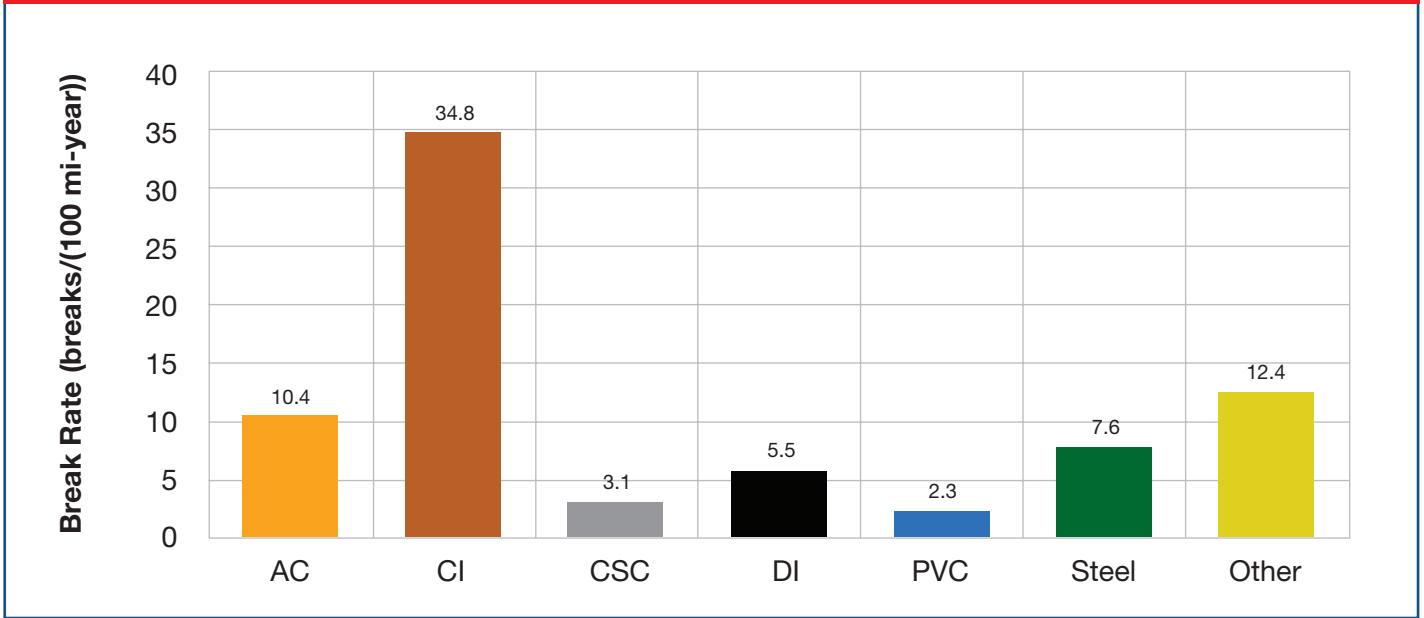
FIGURE 20: BREAK RATES OF EACH PIPE MATERIAL FROM THE BASIC SURVEY

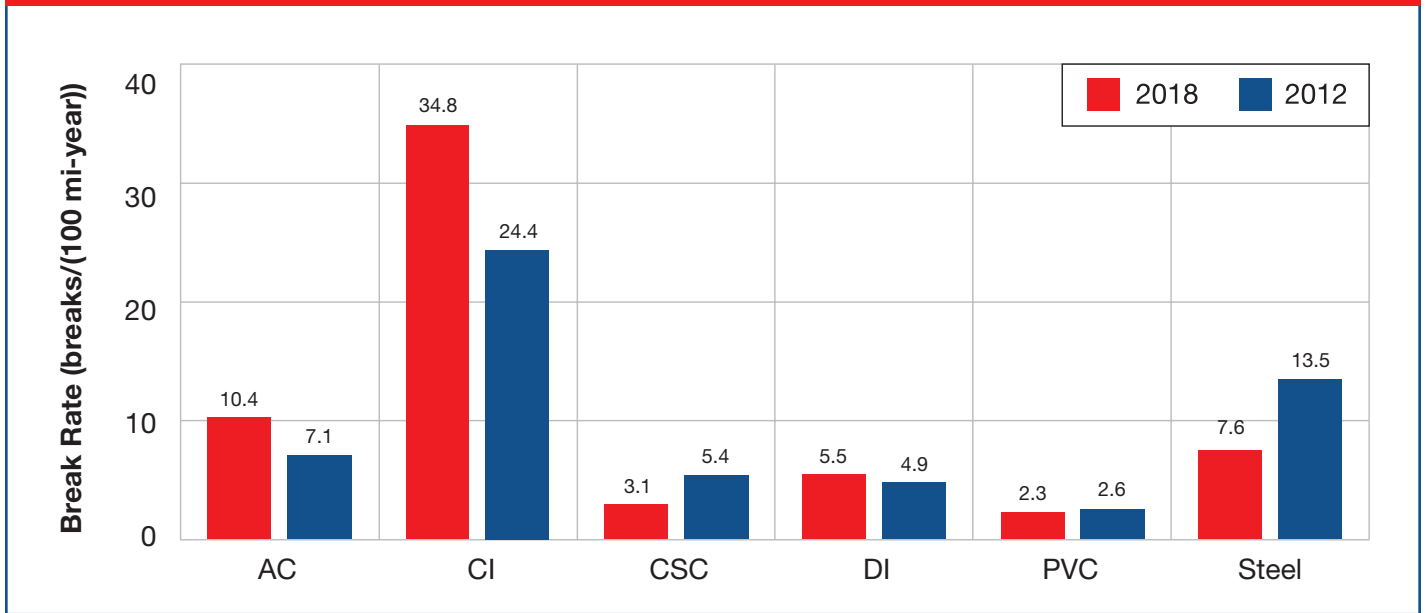
Figure 22 compares the break rates of the 2012 and 2018 surveys. Since over 90% of installed pipe consists of AC, CI, DI, and PVC, the break rates for those material types will be most accurate. From 2012 to 2018, Figure 22 shows a small decrease in break rates for PVC and a small increase for DI pipe. The overall consistency of those values demonstrates they are accurate. Again, the increase in break rates for AC and CI pipes is a very significant observation.

FIGURE 22: COMPARISON OF BREAK RATES OF THE 2018 AND 2012 SURVEYS

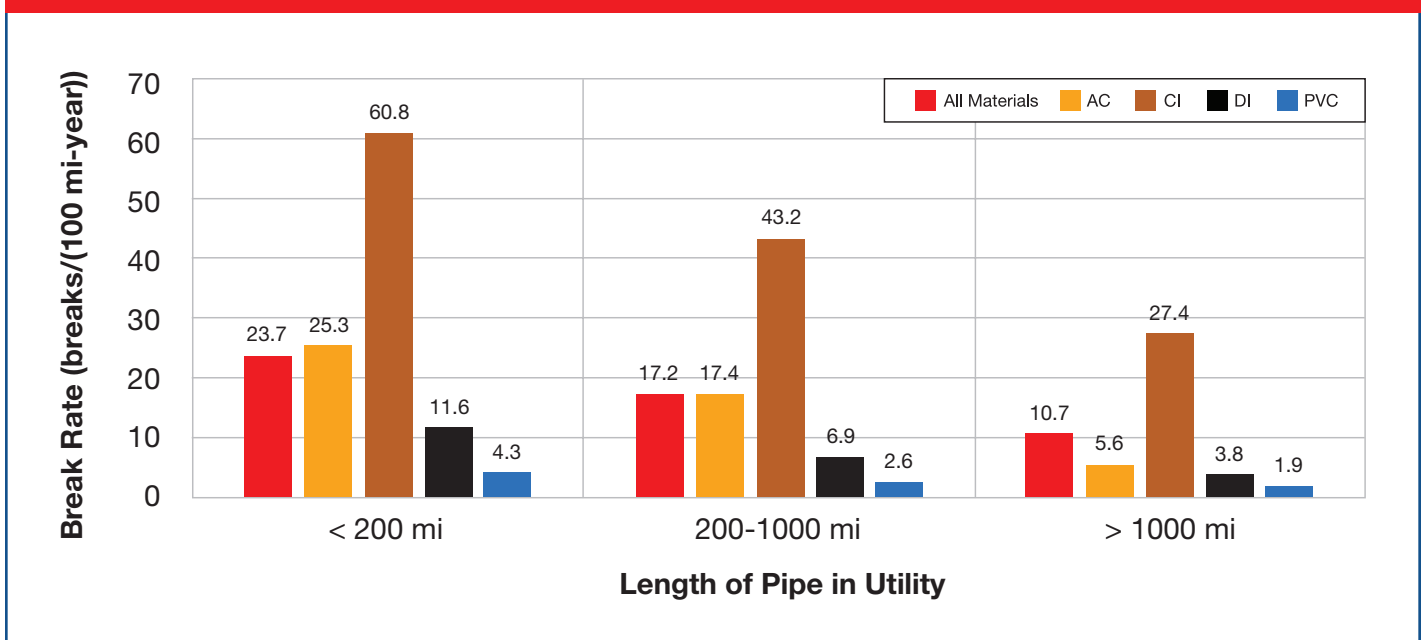
The size of a utility can affect break rates. Three sizes of utilities are considered here based on the length of pipe; small with less than 200 miles, intermediate with 200 to 1000 miles, and large with over 1000 miles. Figure 23 illustrates the overall break rate (for all pipe materials) and then separated by the four most common pipe materials in these three utility sizes. The large utilities consistently had lower break rates than intermediate and smaller utilities. This is likely due to better funding and larger staffs for engineering design, monitoring and information gathering, installation oversight, and repair of water mains. It is very significant that small utilities consistently have break rates at least double that of a large utility.

FIGURE 23: BREAK RATES BY UTILITY SIZE FROM THE BASIC SURVEY

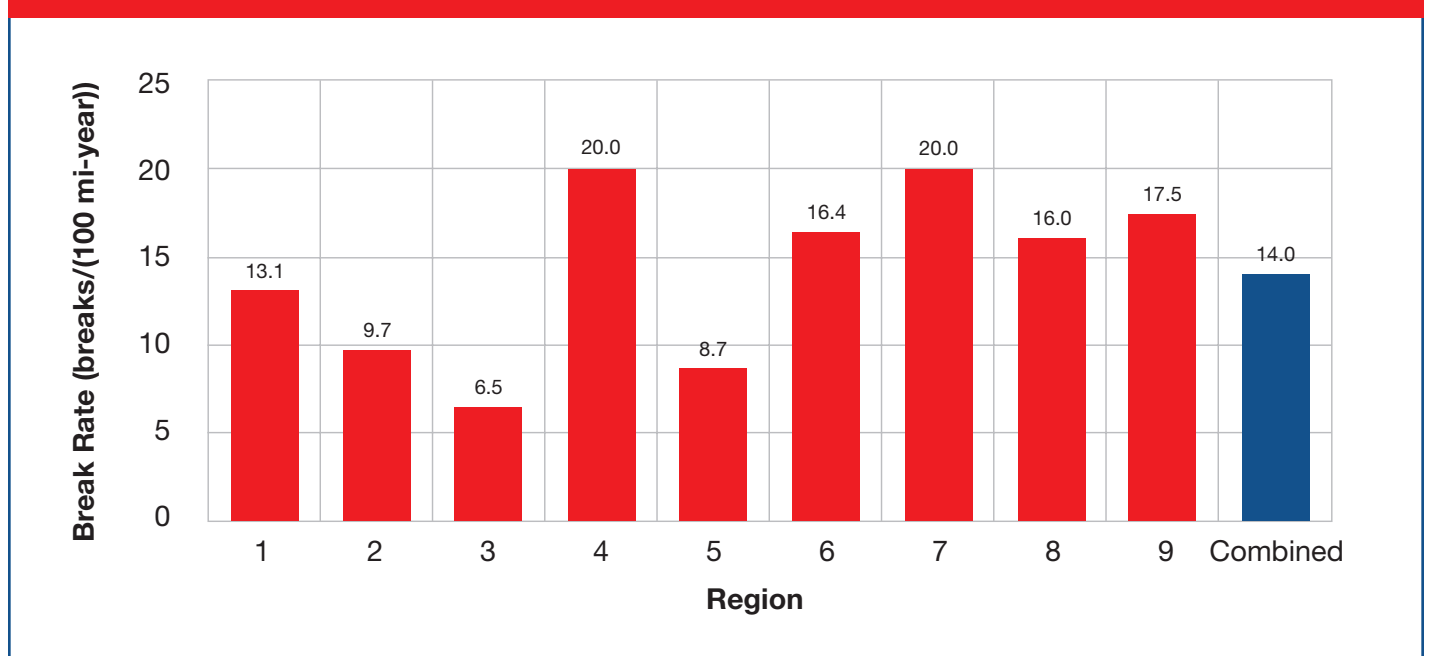
Figure 24 illustrates the overall break rate broken down by region. Clearly not all regions are experiencing the same failure rate. In Table 1, the number of respondents for each region is reported. It was desired to separate US and Canadian break rate data. This is illustrated in Figure 25. Canada can have very corrosive soils (Seargeant, 2013) and this is reflected in the high break rates of cast and ductile iron pipes in Figure 25. Seargeant reported that the highly corrosive soil in Edmonton necessitated a transition from cast iron to asbestos cement pipes in 1966 and then to PVC starting in 1977. The transition to PVC has produced a dramatic reduction in water main break rates for the city.

FIGURE 24: OVERALL BREAK RATES BY REGION FROM THE BASIC SURVEY

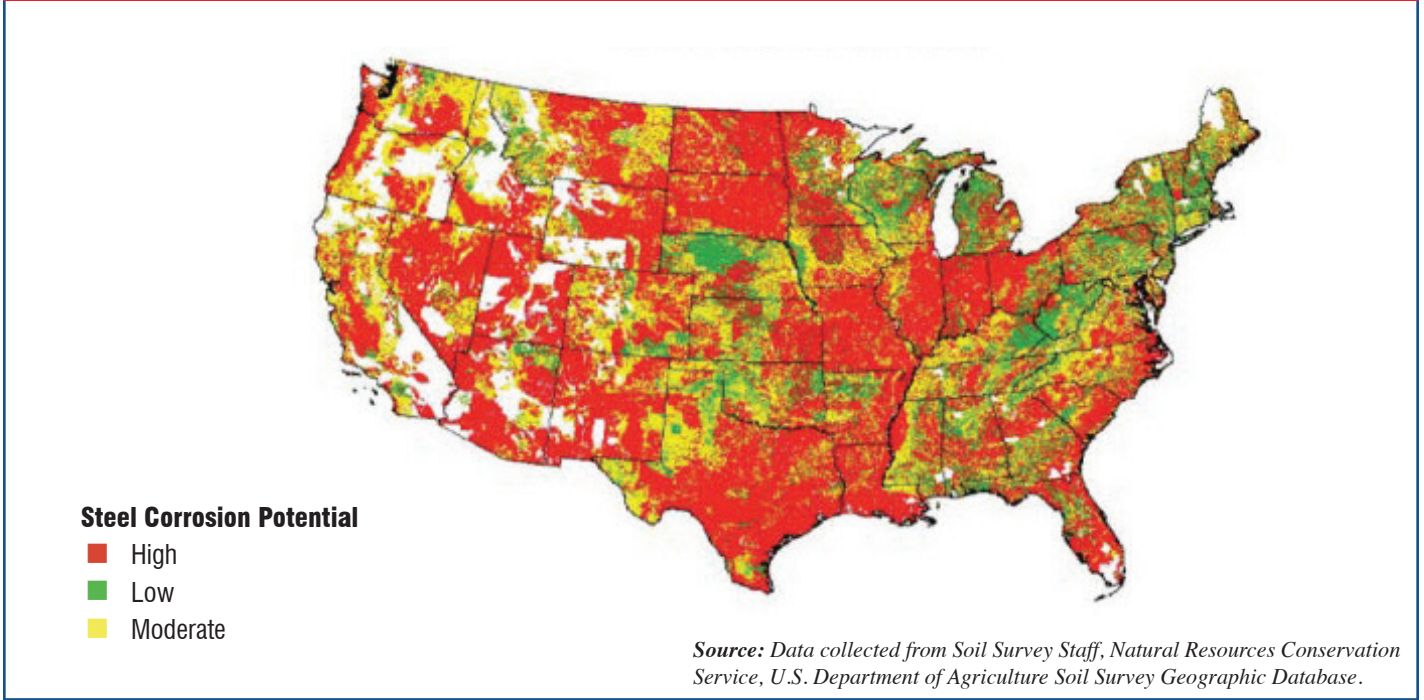
FIGURE 30: US CORROSIVE SOILS MAP (CONUS POTENTIAL FOR STEEL CORROSION)

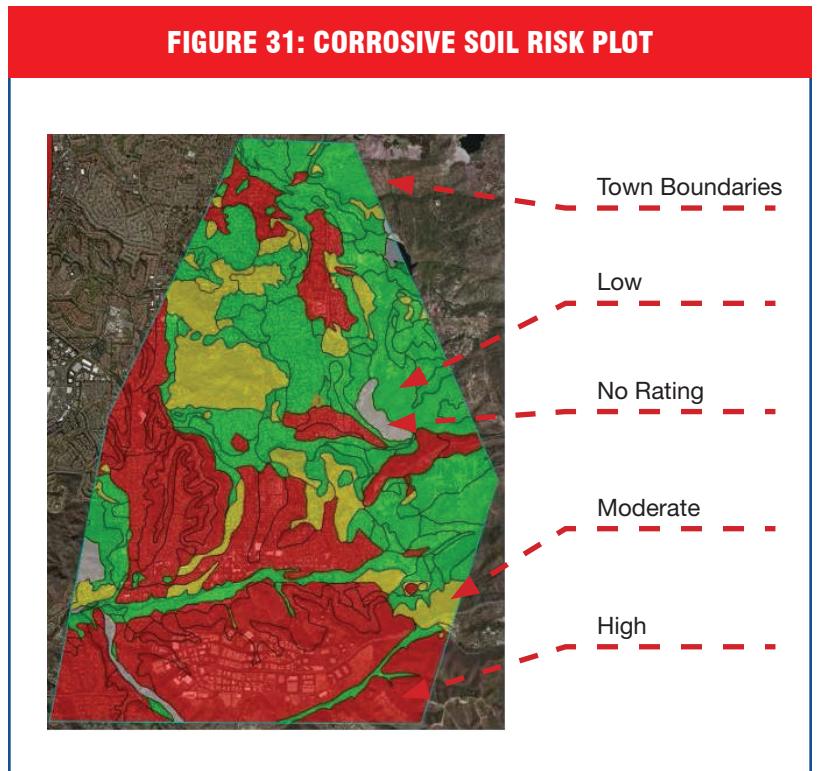
Corrosion index values were computed for 281 cities in the US. Some US cities had little or no data for the soil inside their boundaries preventing computation of a corrosion index. For analysis, the corrosion index values were broken down into seven ranges and the number of utilities in each range is plotted in Figure 32. The average corrosion index for all the US utilities in the basic survey was 2.4 or close to midway between moderate and high corrosion risk. That is, most utilities in the US have a moderate to high soil corrosion risk which is consistent with the detailed survey report that showed 75% of utilities have one or more areas with corrosive soils.

FIGURE 31: CORROSIVE SOIL RISK PLOT

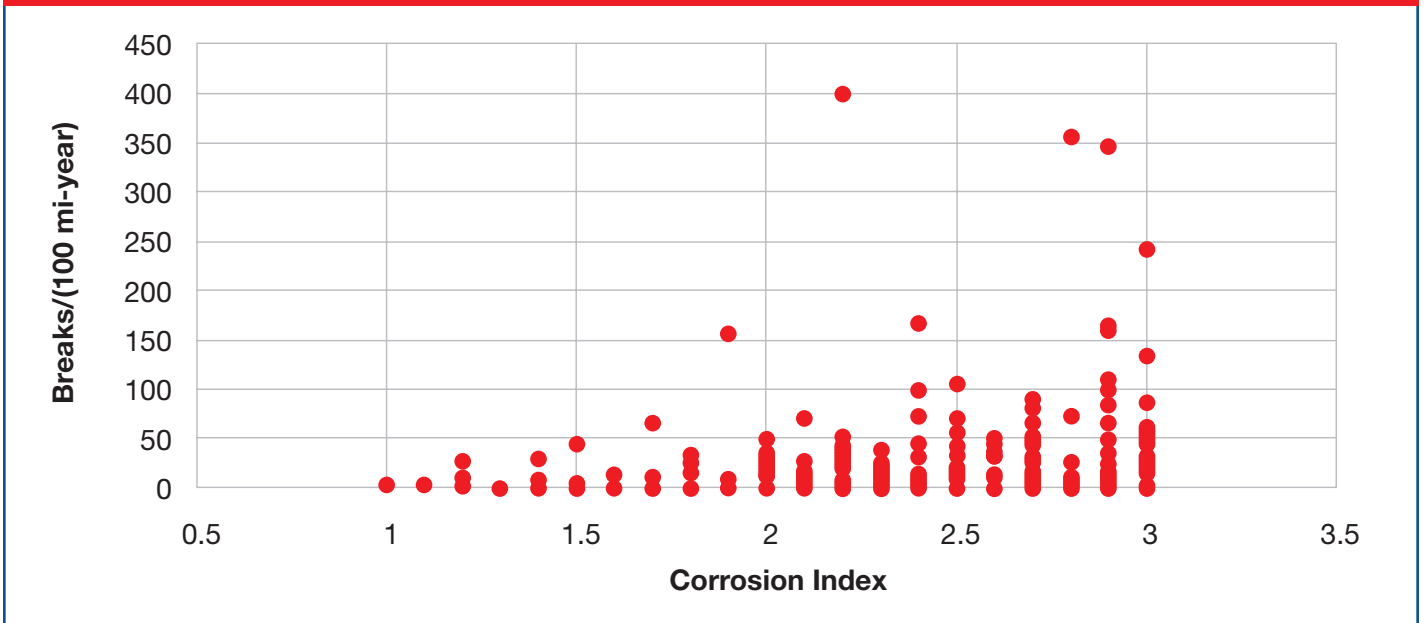
It is reasonable to expect break rates would increase when pipe is installed in corrosive soils. To examine this, plots were made of a utility's corrosion index versus break rate. Figure 33 illustrates this for cast iron pipe. There is a trend of higher break rates with increasing corrosion index, but the wide scatter in the data makes analysis difficult. The high break rates in Figure 33 are associated with small utilities that have a small amount of pipe. Consider a utility with 1 mile of cast iron pipe with 2 breaks during the past year. That would translate to a break rate of 200 breaks/(100 miles)/year. If that utility had no breaks the following year, the break rates drop to zero.

FIGURE 33: INDIVIDUAL UTILITY BREAK RATES FOR CAST IRON PIPE VERSUS THEIR CORROSION INDEX

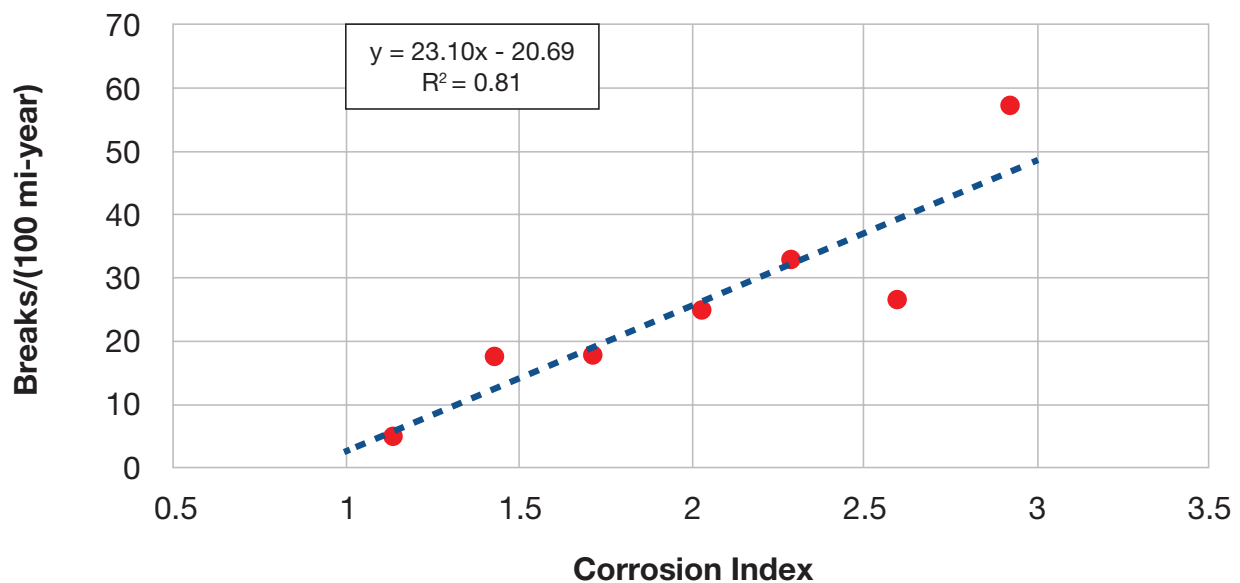
FIGURE 34: CAST IRON PIPE BREAK RATE VERSUS CORROSION INDEX

Using the equations in Figure 34 with $x=1$ for a low corrosion risk and $x=3$ for a high corrosion risk, one can show that a cast iron pipe in a high corrosion soil is expected to have over 20 times the break rate of one in a low corrosion soil. Similarly, ductile iron pipe in a high corrosion soil has over 10 times the break rate than one in a low corrosion soil. Very poor correlations were found for the other material types in this survey.

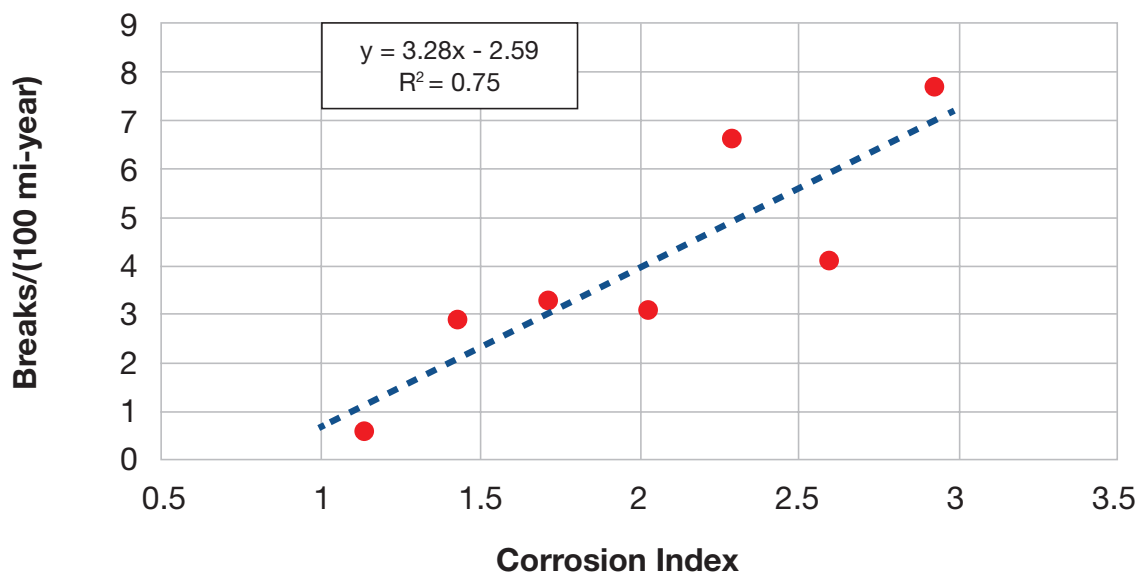
FIGURE 35: DUCTILE IRON PIPE BREAK RATE VERSUS CORROSION INDEX

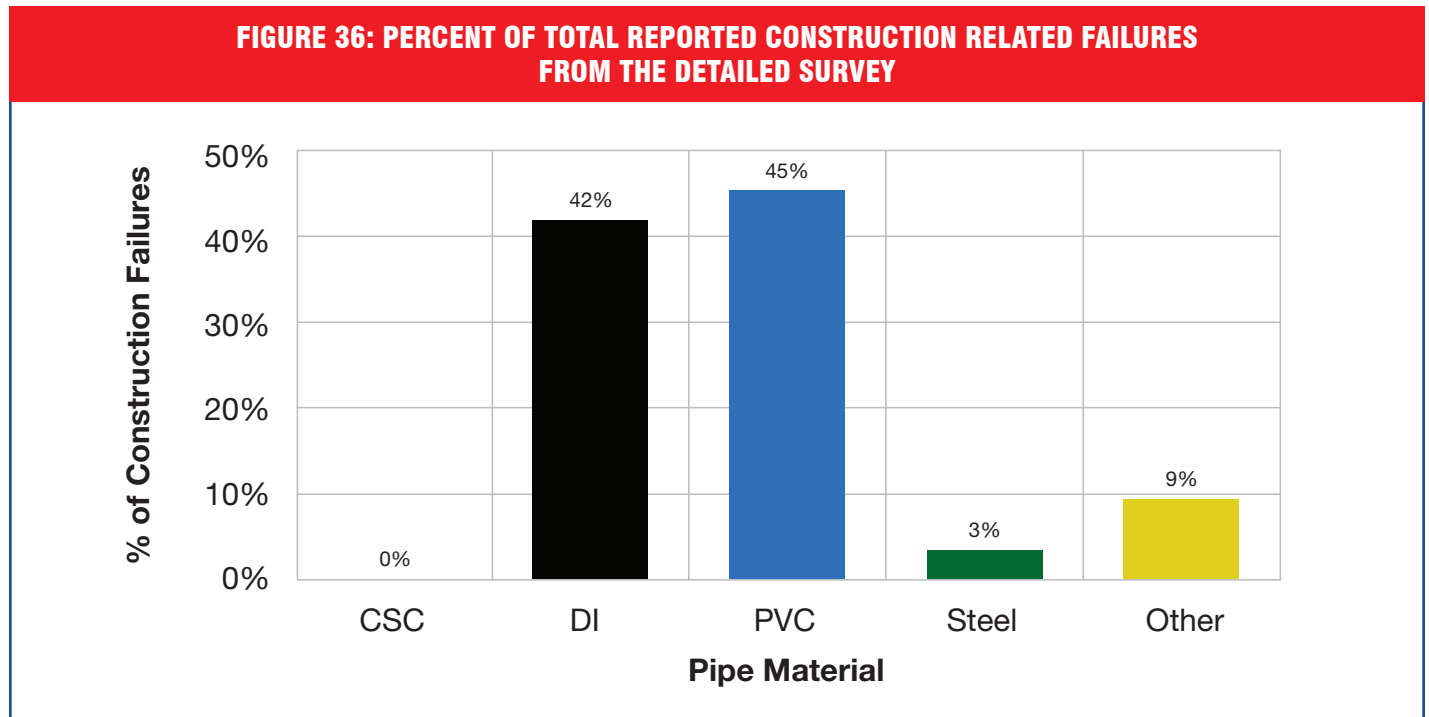
The detailed survey asked respondents to report failures related to construction activities. Figure 36 illustrates the percentage of total construction failure related to a particular pipe material. Ductile iron and PVC pipes have the majority of construction related failures at a nearly equal frequency. Figure 14 shows that DI and PVC are the two pipe materials that are also most commonly being installed today. This points to the need to improve construction practices for underground infrastructure regarding installation, location services and inspection.

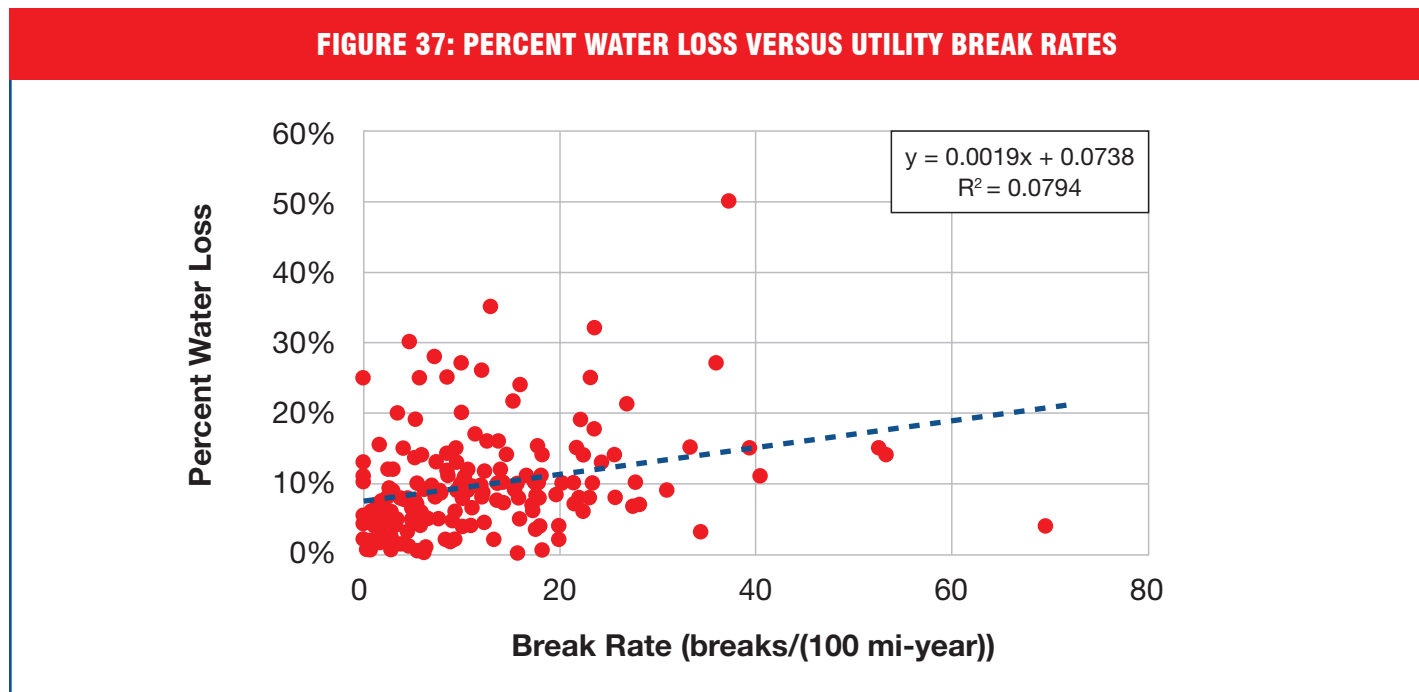
FIGURE 37: PERCENT WATER LOSS VERSUS UTILITY BREAK RATES

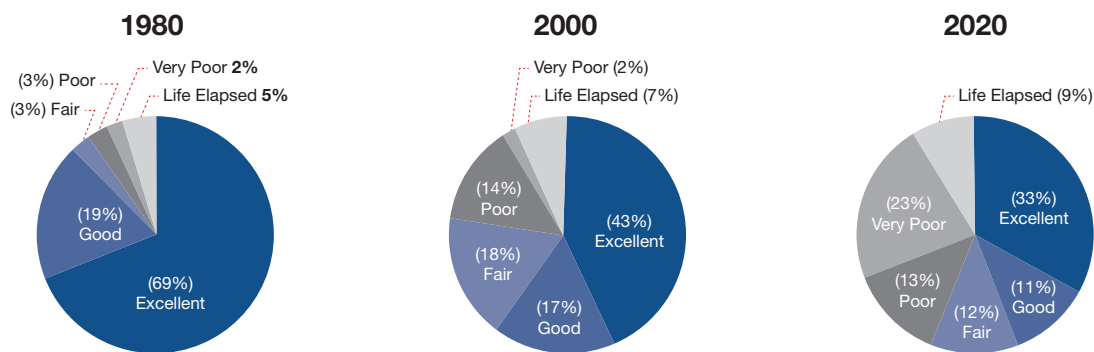
FIGURE 38: ASSESSMENT OF PIPE CONDITION WITH TIME (FROM EPA, 2002)

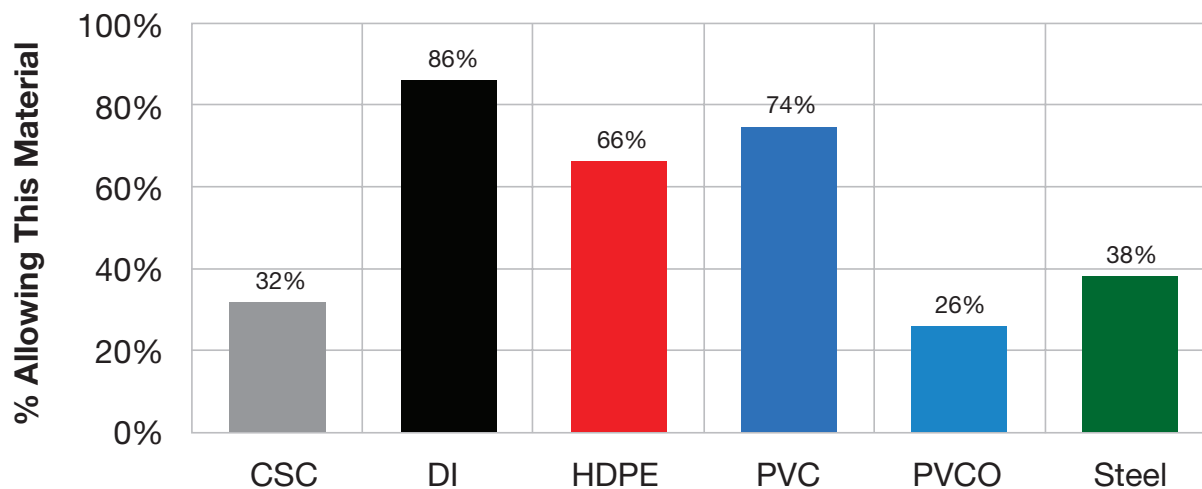
FIGURE 39: RESPONDENTS ALLOWING INSTALLATION OF THESE WATER MAIN MATERIALS

The detailed survey also asked respondents what water main pipe materials are currently approved for use at their utility. Figure 39 illustrates the percentage of respondents that allow a particular pipe material to be installed. HDPE pipe at 66% allowance for use in water systems represents a high degree of acceptance for trenchless applications such as pipe bursting and directional drilling, whereas for open cut installations PVC and ductile iron pipe are the predominantly accepted materials (see Table 10). Figure 40 compares the pipe materials approved for use by utilities in the 2018 survey with the data obtained in the 2012 survey. Figure 40 shows a 23% increase in the acceptance of PVC water pipe by North American utilities since 2012. Specifically, PVC pipe approval among survey respondents increased from 60% of water utilities allowing its use in 2012 to 74% of utilities allowing its use in 2018. The number of utilities approving of ductile iron, concrete steel cylinder, and steel pipes for use in water systems remains essentially the same.
