# HYDRAULIC ANALYSIS:

Pumping Costs for PVC  
and Ductile Iron Pipe

Uni-Bell PVC Pipe Association  
2711 LBJ Freeway, Suite 1000  
Dallas, TX 75234

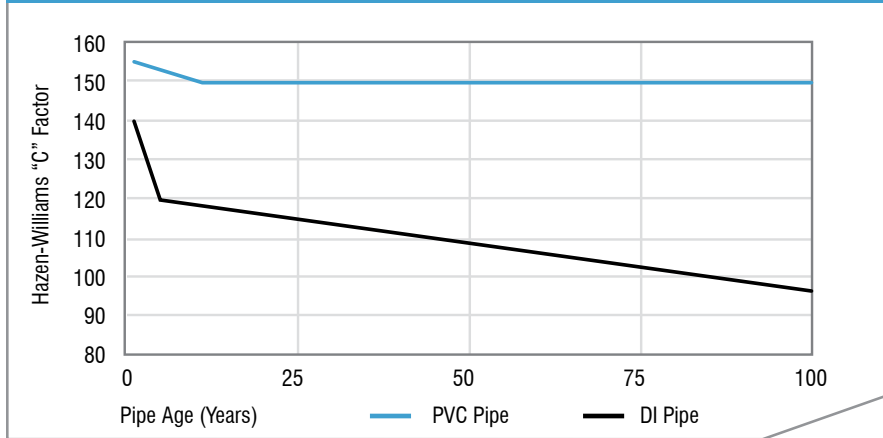
FIGURE 1: "C" VALUES FOR PVC AND DI PIPE PER SSC STUDY

The "Life Cycle Assessment of PVC Water and Sewer Pipe and Comparative Sustainability Analysis of Pipe Materials"<sup>5</sup> report by Sustainable Solutions Corporation (SSC) analyzed "C" factor deterioration for pipe materials over a 100-year design life ([click here](#) to view). The report assigns an initial "C" value of 155 for PVC pipe which declines to a value of 150. The SSC study shows that DI experiences a rapid initial decline from a "C" value of 140, then a gradual degradation rate thereafter. The gradual "C" factor decline in the SSC study of 2.5 per decade is consistent with the

City of Detroit's findings published in its "Comprehensive Water Master Plan"<sup>6</sup> developed by CDM Smith and CH2M Hill ([click here](#) to view). Figure 1 shows the "C" value deterioration for PVC and DI pipe over a 100-year design life. Detroit's analysis shows that the pumping efficiency for DI pipe continually declines with age and does not remain at factory specifications.

To accurately calculate flow characteristics over time, correct "C" values for pipe must be used. As shown, for PVC pipe its "C" value remains at 150 after an initial decline from 155. For this analysis, the "C" factors for DI pipe are based on the SSC report (see Figure 1 and blue dashed lines in Figure 4). DI pipe's "C" value declines at an annual rate of 0.25 after an initial decline from 140. Figures 3 and 4 show that DI pipe's degradation rate can be much worse.

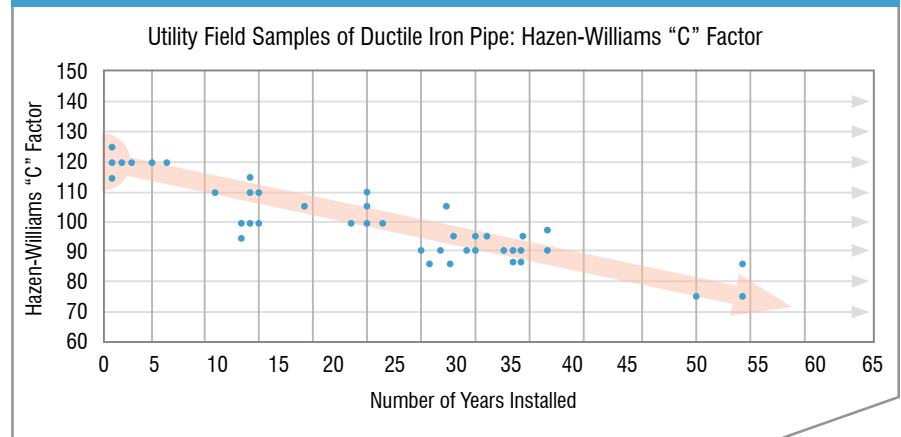
FIGURE 2: FIELD SAMPLES SHOWING DECLINING "C" FACTOR FOR DI PIPE

Detroit's degradation rate for DI pipe's cement-mortar lining is better than found in many other studies. However, the decline in DI's pumping efficiency can be much worse. As shown in Figure 2, field samples of over 60 mortar-lined DI pipes from the Western Virginia Water Authority demonstrate how the "C" factor decreased from 125 to 75 over a 55-year timeframe. The Washington Suburban Sanitary Commission provided 27 iron pipe field data samples which show a similar trend.<sup>7,8</sup> Design conditions may need to take into consideration greater declines in the Hazen-Williams "C" factor for DI pipe.

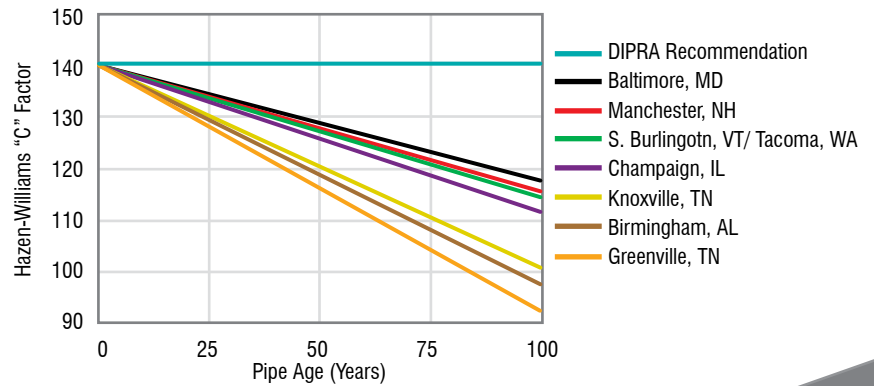
FIGURE 3: "C" VALUES FOR DI PIPE / DIPRA BROCHURE

- ▶ A DIPRA brochure titled "Cement-Mortar Linings for Ductile Iron Pipe"<sup>9</sup> recommends "C" to be 140 for the life of the DI pipe. However, data in the same document show that for eight DI-using cities, "C" deteriorates between 0.22 and 0.46 annually (see Figure 3).
- ▶ Other studies show similar, even more dramatic results (see Figure 4). Additionally, a 2017 study from Virginia Tech University states: "The assumption of the head loss being constant for DI pipe throughout the life is an incorrect assumption. The Hazen-Williams factor and the effective diameter decrease with time due to internal corrosion and tuberculation in the DI pipe."<sup>10</sup>

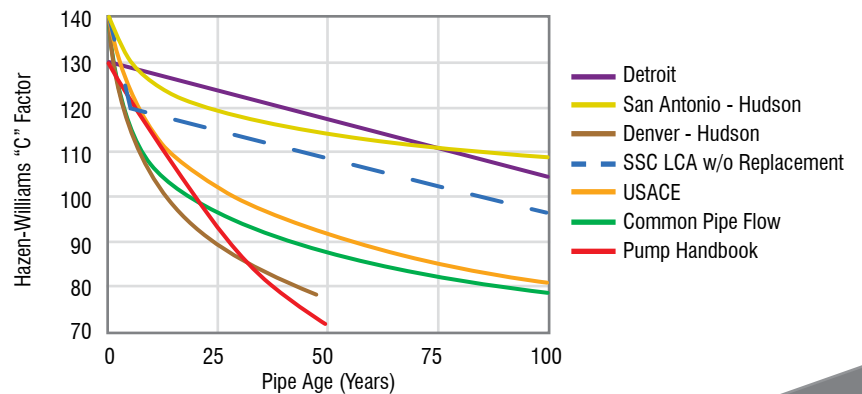
FIGURE 4: "C" VALUES FOR DI PIPE / STUDIES

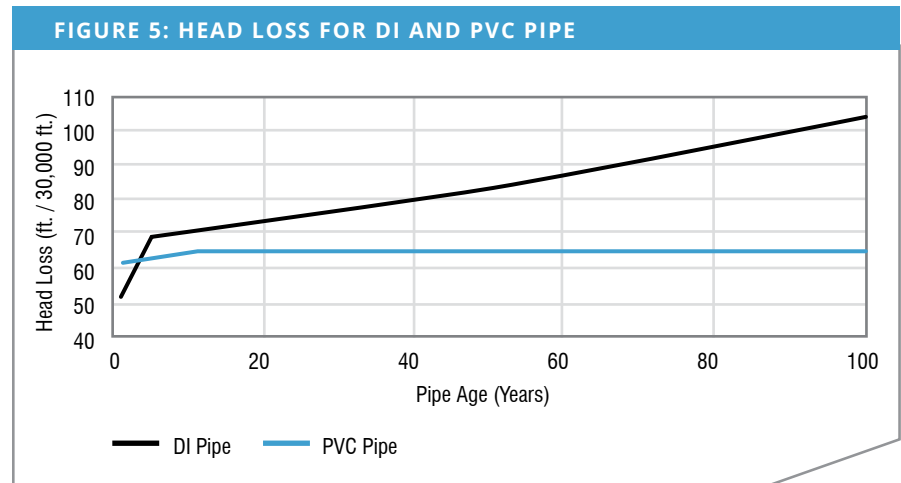
These results show that when an unbiased comparison is undertaken over the design life of a pipeline, PVC's design head loss is less than DI pipe's. Figure 5 shows the anticipated head loss for the 24-inch 30,000 ft. pipeline and illustrates the effect of the deterioration of DI's "C" factor.

► **Year 1:** Using the same design equations as DIPRA, the head loss for 24-inch DI PC200 pipe is 1.73 ft./1,000 ft. With the same analysis method, head loss for 24" PVC PC200 pipe is 2.04 ft./1,000 ft.

► **Year 4:** The "C" value for DI pipe has declined causing DI's head loss to be 2.13 ft./1,000 ft., greater than PVC pipe's head loss of 2.08 ft./1,000 ft.

► **Year 100:** If DI pipe were not already replaced due to corrosion, DI's "C" value will have deteriorated to just over 96 resulting in a head loss of 3.46 ft./1,000 ft., about 60% higher than PVC pipe's head loss of 2.17 ft./1,000 ft.

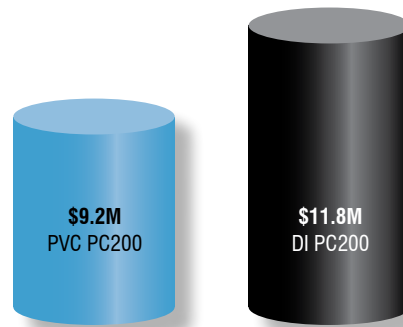
**FIGURE 6: CUMULATIVE 100-YEAR PUMPING COSTS COMPARISON FOR 24" PVC AND DI PC200 PIPE\***

\*Rising cost of electricity not included. If this was taken into account, the cost savings using PVC pipe would be even greater.

Using the design example's parameters, including "C" value deterioration, the pumping costs over a 100-year period for a 30,000 ft. DI PC200 pipeline would be \$11.8 million. For a 30,000 ft. PVC PC200 pipeline, the total pumping costs over a 100-year period would be only \$9.2 million (see Figure 6).

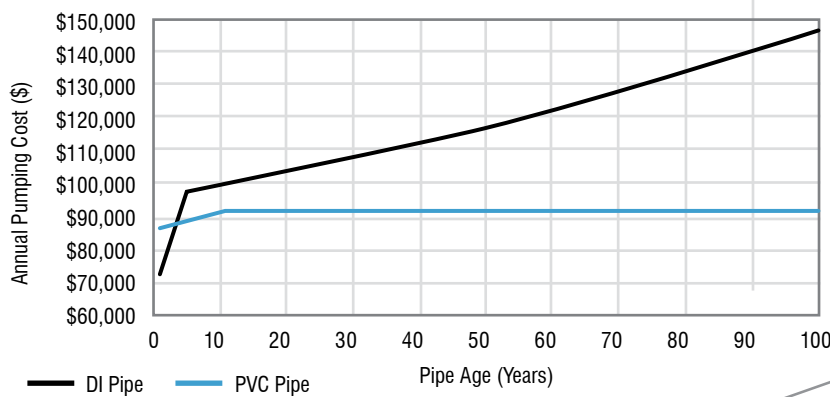
**FIGURE 7: ANNUAL PUMPING FOR DI AND PVC PIPE**

Figure 7 shows the annual pumping costs for the 30,000 ft. pipeline. As with the head loss calculations, to determine total pumping cost over time, pumping cost must be computed for each year using the corresponding annual head loss. The pumping cost over the design life is then the sum of the yearly pumping costs. The average annual pumping cost is the total pumping costs divided by the design life. Below are highlights of the calculations. The 100-year average annual costs would be:

- ▶ For DI PC200 pipe: \$118,000 (ranging from \$73,300 to \$146,600)
- ▶ For PVC PC200 pipe: \$91,700 (ranging from \$86,500 to \$91,900)

DI pipe's 100-year average annual cost would be \$26,300 greater than PVC.
